REPORT NO. 02-15

NAILED FLOOR-LINE BLOCKING METHODS TP-94-01, "TRANSPORTABILITY TESTING PROCEDURES"

Nailed Floor-Line Blocking Methods TP-94-01, "Transportability Testing Procedures"

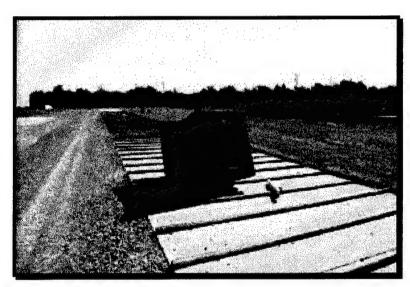
- 1. Figure 6 lists the average speeds of the test load through the Hazard Course.
- 2. Inspection following Pass #4 revealed that the load moved 0.5 inches toward the door of the trailer.
- 3. Inspection following Passes #3 and #4 revealed no excessive movement of the payload or damage to the trailer or blocking and bracing.
- 5. <u>WASHBOARD COURSE</u>. The washboard test was conducted for informational purposes only. The rear header (door end) separated from the trailer floor. This allowed the entire load to move toward the trailer door. One pallet of the PA116 Containers fell from the trailer.

Photo 15. PA116 Container Pallet After Dropping From the Trailer During Washboard Course

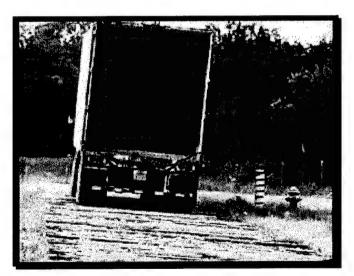
Photo 19. Washboard Course Testing of the PA116 Containers on Wood Pallets

- 1. Figure 8 lists the average speeds of the test load through the Hazard Course.
- 2. Inspection following Pass #3 revealed that the load moved 0.5 inches forward.
- 3. Inspection following Passes #3 and #4 revealed no excessive movement of the payload, damage to the trailer or blocking and bracing.
- 5. <u>WASHBOARD COURSE</u>: The washboard test was conducted for informational purposes only. Inspection following the completion of the test revealed that the load had moved toward the rear of the trailer 2.6 inches.

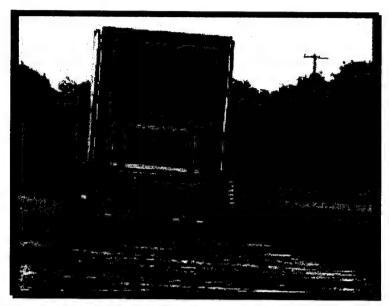
Photo 23. Washboard Course Testing of the 155MM SLP Payload

- 1. The washboard test was conducted for informational purposes only.
- 2. The load-bearing gate, at the trailer door was damaged. During transport over the hazard course the passenger side bay of 155MM SLPs bounced onto the end blocking. The load moved toward the door of the trailer and damaged the gate.
- 3. The end blocking separated from the floor 0.3 inches at the door end of the trailer.
- 4. The end blocking (closed end) of the second bay of 155MM SLPs moved forward 0.25 inches due to the nails bending.
- 5. The load bearing gate (door end) fill piece of the second bay of 155MM SLPs disengaged.
